<u>The New Hampshire Municipal Energy</u> <u>Assistance Program</u>

Decision Grade Audit Report

New Castle Town Hall 49 Main Street New Castle, NH 03854

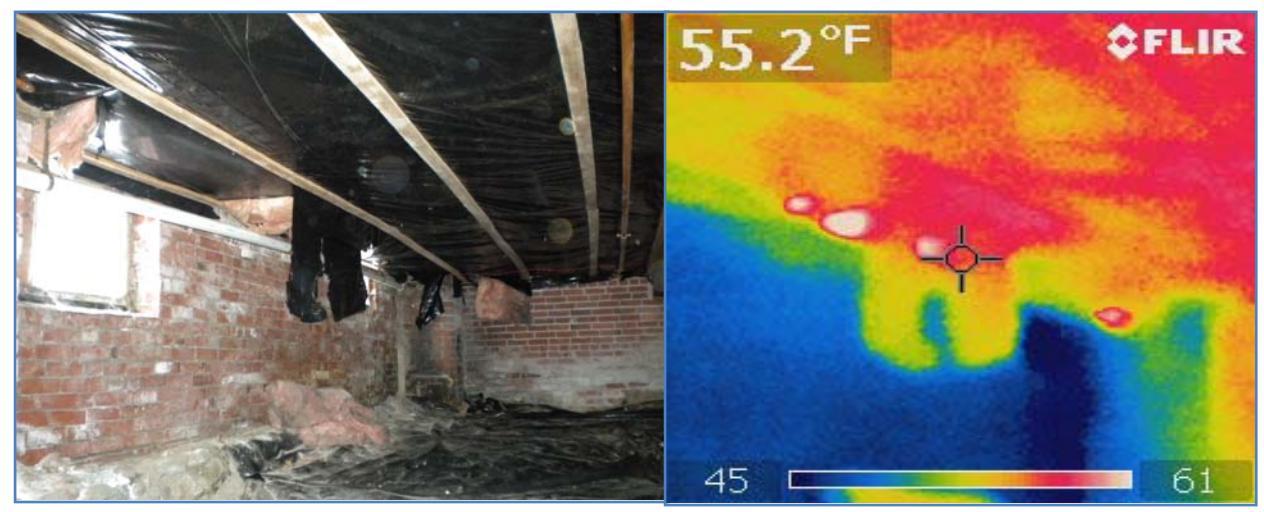
Figure 7

The building sits over a crawl space that ranges in height from about three feet to five feet. One corner of the building sits almost entirely on ledge. The foundation wall is a mix of brick and granite, and as seen in Figure 7, there is a great deal of heat-loss from this wall. There is a poly moisture barrier on the dirt floor of the crawl space. Fiberglass batt insulation is found between the floor joists ranging in thickness from 3.5 inches to 5.5 inches with areas of no insulation. As seen in Figure 7, there is a poly barrier against this that is poorly sealed and falling down in many areas. Though this is certainly better than no insulation at all, it is still minimally effective because of the amount of air able to rise from the crawl space to the first floor. Furthermore, there are several duct grills in the floor which also allow for air passage between the two spaces. This duct work from a previous heating system has ducts running to the unoccupied second floor, allowing for cold air to capture heat and rise through the system creating a series of small chimneys pulling heat towards the mostly uninsulated second floor.

- Insulate the foundation walls. This should be done with closed-cell spray foam applied at a thickness of 2 inches to the entire perimeter of the foundation. The fiberglass insulation and poly barrier should be pulled away from underneath the floor around the edges of the floor so that the foam can be sprayed up past the band joist, slightly over lapping the floor boards. The fiberglass and poly barrier can then be put back in place. Depending on local codes, it may be necessary to spray an ignition barrier over the foam.
- There is a small access door to the crawl space seen in Figure 8. We recommend fastening this door in place and spraying it with foam. The access to the crawl space

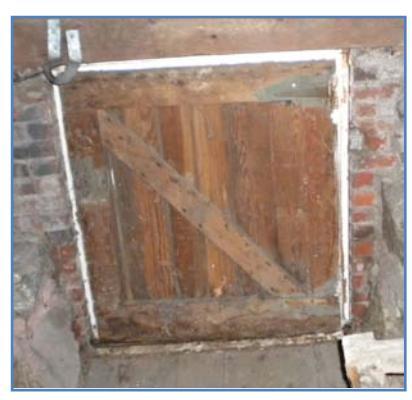
- There is a small access door to the crawl space seen in Figure 8. We recommend fastening this door in place and spraying it with foam. The access to the crawl space from the mechanical room should suffice.

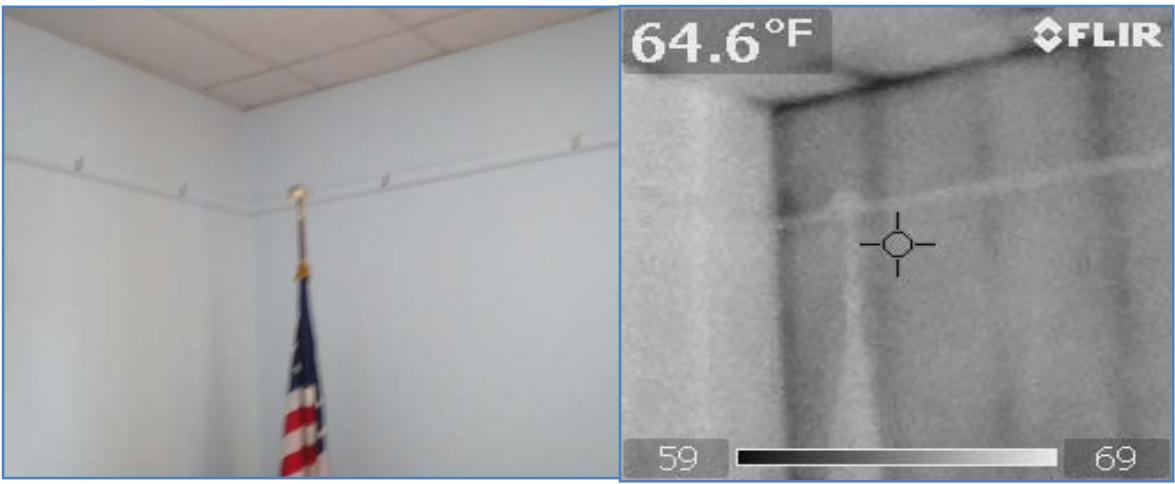
The exterior walls are constructed with 2x4 wood framing, and are for the most part insulated with R-11 fiberglass batts. The vertical dark lines in Figure 9 are wall studs. They appear to be cold because of their low R-value. This means that heat is conducting through them faster than the insulation leaving them to serve as a thermal bridge from the interior to the exterior. Only the first floor walls have any insulation, except where it continues up the exterior walls of the stair well.

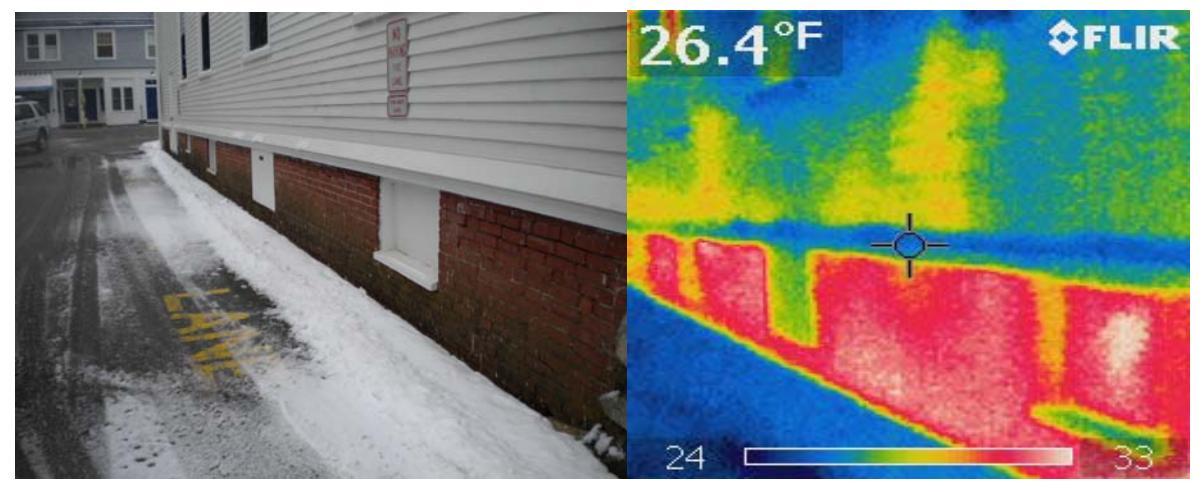
Some of the exteriors walls still have the original chair rail with wainscoting below. It appears as though when the building was renovated in 1980, there was an attempt to drop rock wool down into the wall cavities behind the trim and wainscot. During our site visits, we were able to find empty wall cavities, and cavities that were not adequately filled. Warm spots show up as yellow areas in Figure 10 revealing these weak points in the building envelope. Above the wainscot is where the fiberglass insulation begins.

It could be possible to blow cellulose in the lower portion of this wall to deal with the weak spots; however, this may be more effort than it's worth. Our recommendation is to focus air-seal and insulation efforts on the ceiling and crawl space at this time. Figure 11 shows an example of a double stud wall. In this case, it would take a major renovation to accomplish this. It would require removing all of the exterior wall finish, building a second exterior wall against the first, then re-insulating the wall. It would also require moving electric boxes, radiators, and fabricating jamb extensions for the window trim. Because energy prices are still relatively low, this type of project would require consideration towards the long term use and environmental impacts of operating this building.

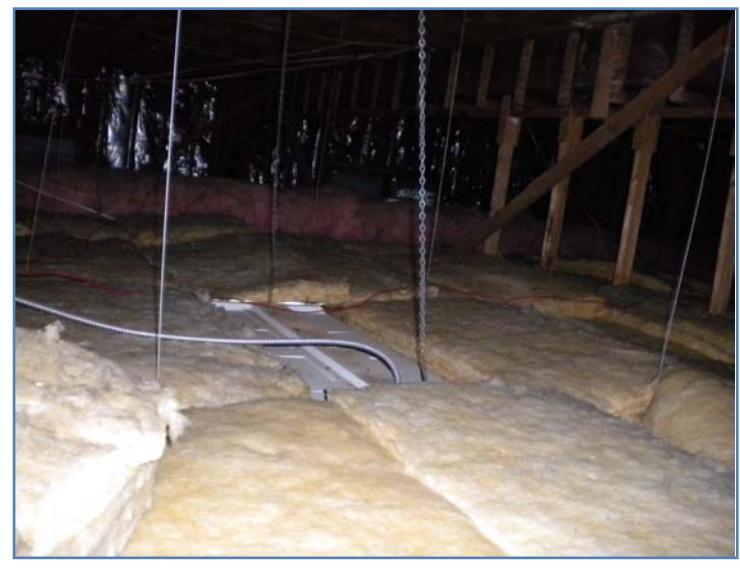
There are suspended ceilings above the offices and Selectmen's room and sheetrock above the hall with fiberglass batts sitting on top of both areas, seen in Figure 12. Though this serves to contain some of the heat from the first floor, it is a poor example of a thermal barrier as air can move relatively freely from the first floor space to the space above. Once on the other side of the insulation, there is very little keeping the heat from exiting the building.

The sheetrock against the exterior walls only continues a few inches above the suspended ceiling. Above this are exposed floor joists, decking boards, and the finished floor of the second story. Figure 13 shows exposed studs with fiberglass insulation stuffed between. Even though the fiberglass batts are foil faced, this is an ineffective vapor barrier.

- Insulate the ceilings above the first floor. This should be done with closed-cell spray foam applied at a thickness minimum of 4 inches.
- Remove the fiberglass batt insulation from the exterior walls of the first floor above the suspended ceiling and continue the closed-cell spray foam down the exterior wall applied at a thickness of 3 inches, overlapping the face of all wooden structures stopping at the top of the sheetrock.
- Insulate the two interior walls at the top of the stair well. This should be done with dense pack cellulose insulation.
- Apply weather stripping to the jambs of the two doors at the top landing of the stairs. Foam board insulation could also be temporarily fastened to these doors for added R-value.

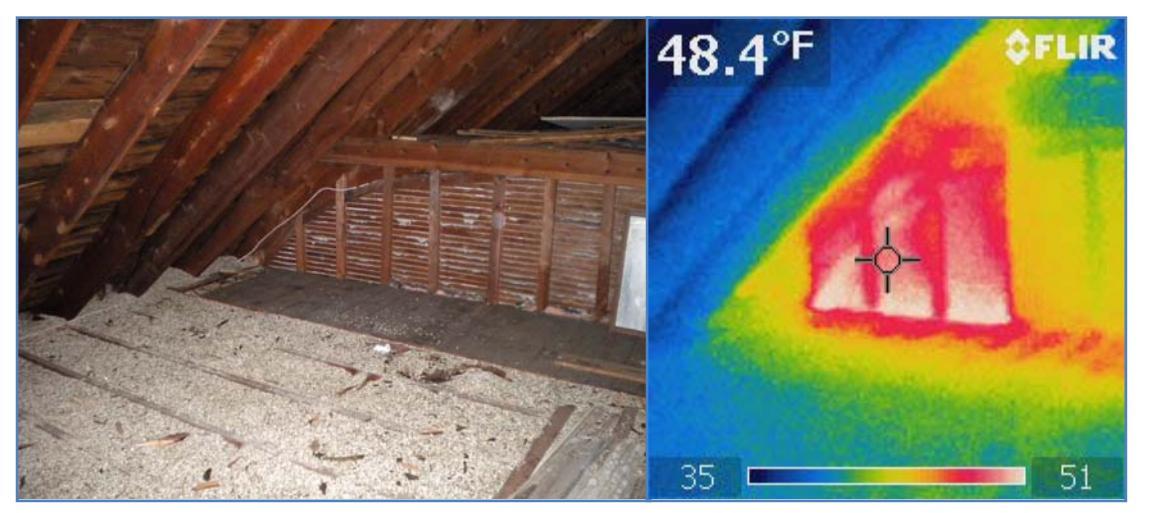
Figures 14, 15 and 16 display some of the ways in which heat moves through the second floor ceiling after it has made it past the first floor. About half of the second floor ceiling is insulated with 8 to 10 inches of vermiculite insulation which only has an R-value of about 2 per inch. This R-20 at best is only 1/3 of what is required by today's building codes. In order to improve this area of the ceiling, we would recommend having the vermiculite removed by a certified company, ceiling any penetrations to the space below, and re-insulating the ceiling with cellulose insulation.

Also visible in Figure 14 is a large amount of heat coming from the wall cavities of the partition wall. What is likely occurring here is the following:

Because of the framing technique used at the time this building was constructed, there may not be a bottom plate underneath the studs. This means that heat lost through the first floor ceiling is rising up and being pulled into this wall like the flue of a chimney and then deposited in the attic space.

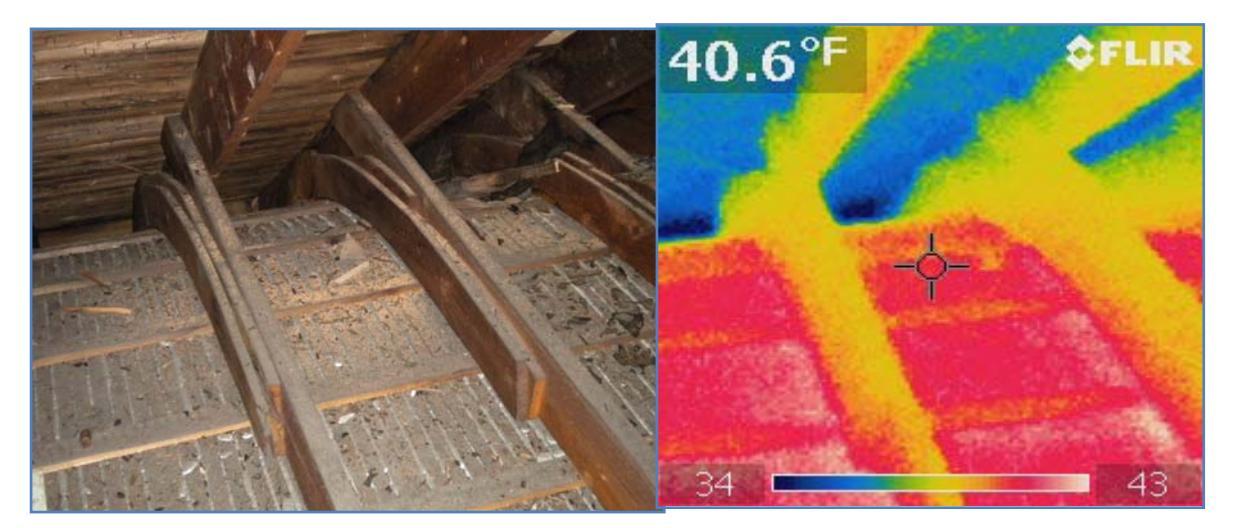
Figure 15 shows the sloped ceilings above the main room of the second floor. As we can see, there is no insulation at all and a large amount of heat is radiating from this surface.

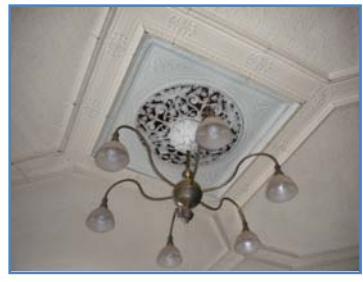
Figure 16 shows a beautifully crafted metal ventilation grill above the main room of the second floor. Its original purpose was likely to help vent heat from the space during functions taking place in the warmer months. Unfortunately, it is drawing heat from the building years round.

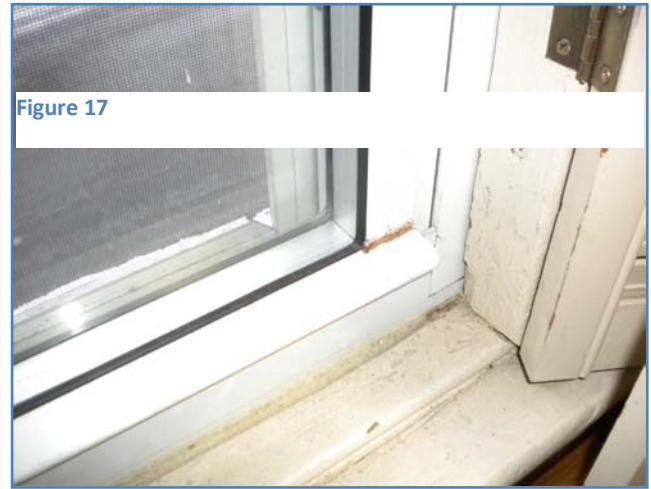
There are three exterior doors, 2 wood and 1 metal foam core. Steps should be taken to ensure that these doors have a good seal. Most of the windows on the first floor have been replaced with double pane replacement windows. While there are more efficient windows on the market today, we do not recommend replacing the existing windows at this time. This would only be done in conjunction with a major renovation of the first story walls. There are many cracks and gaps where the replacement windows meet

the original trim. See Figure 17. These should be filled with caulking to reduce air infiltration from around these units. There are a few original windows still in place; one towards the rear of the building by the back door, one in the stair well, and one located at the top of the stair well. All have storm windows. We would not recommend replacing these windows at this time.

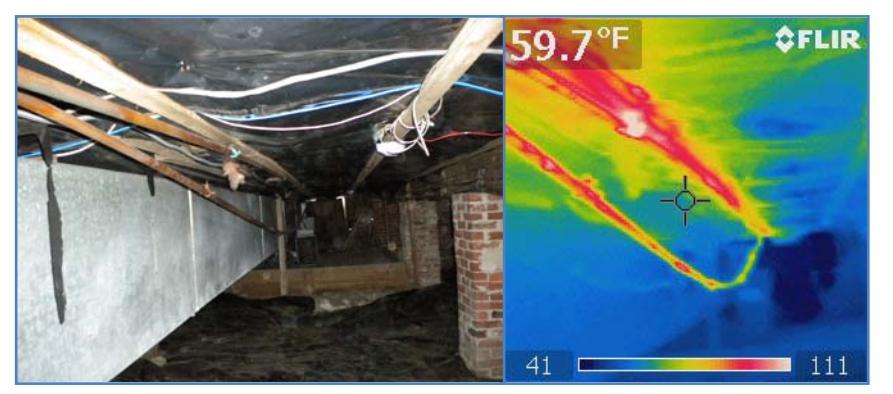
Figure 20

Visible in Figure 20, several of the copper distribution pipes in the basement have pulled away from where they were fastened to the bottom of the floor joists leaving them hanging down far below their original placement. Because of this, there is a serious risk of them bursting. This should be addressed immediately. Also visible here, and in Figures 21 and 22, is that none of the pipes are insulated. This should also be corrected immediately and is a low cost item.

- Arrange for an HVAC technician to come as soon as possible to affix the fallen pipes back into their original position.
- Insulate all of the copper piping in the crawl space and mechanical room, both for the heating system and the DHW system. Make sure this is done with special attention to detail, using a high R-value pipe insulation.
- Replace the two older thermostats with digital/programmable units. Determine a good schedule for temperature in the different zones and program set back temperatures appropriately. The schedule may vary between zones depending on the amounts of use.
- Install an outdoor reset to the boiler. These units are most effective when the boiler is connected to an indirect hot water heater, but even under the scenario, this unit should reduce consumption by about 5% to 7%.

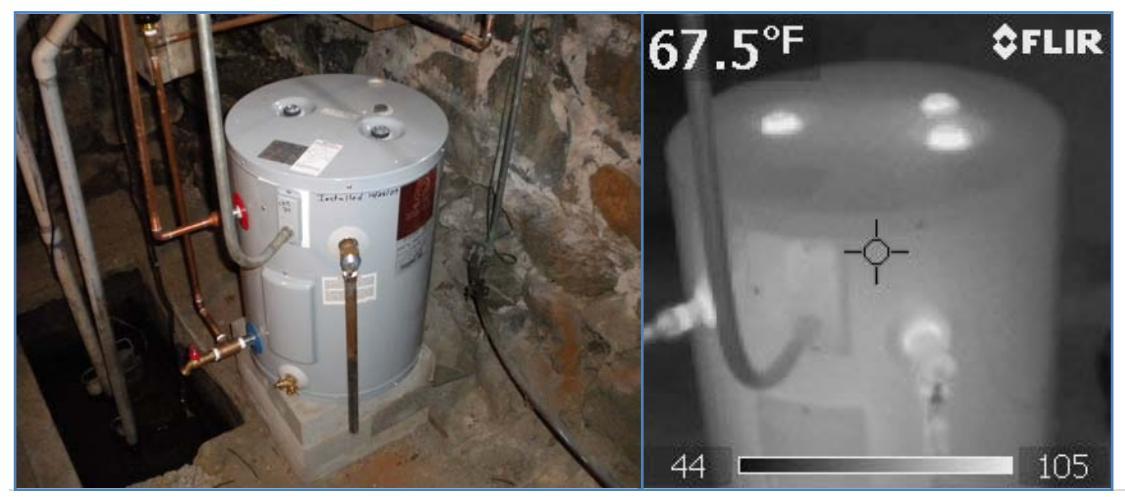
There is an electric hot water heater in the mechanical room. None of the pipes associated with this unit are insulated either.

- Insulate all the DHW pipes in the mechanical room. Wrapping the heater with more insulation would be easy and likely produce more savings.
- Consider installing a photovoltaic system on site. After reducing electrical needs through equipment upgrades and behavioral changes, local generation of electricity is always a great option.

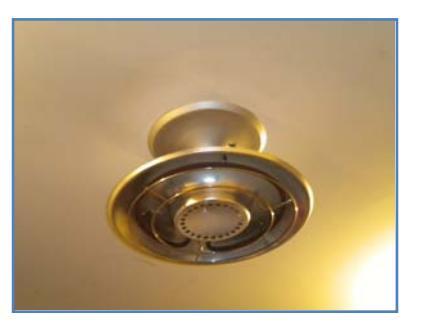
Figure 23

In the fire proof file room, there is an electrical heating element on the ceiling. See Figure 23. Though the thermostat for this unit is set to a low temperature, it still draws a fair amount of electricity. The question was raised of how important it is to keep this small room to temperature. The

outcome of the discussion was that it may be a good idea to try shutting the unit down, and monitor the conditions of the room. If it is found that the cold temperature has no negative effect on the files, and the relative humidity remains at acceptable levels, than use of the unit may not be necessary.

- Finish upgrading the lighting to more efficient units.
- Discontinue the use of the electric space heater in the file room and monitor the conditions to ensure proper climate needed to store documents.
- Try to plug as much equipment as possible into smart strips, and turn off the strips at night and on weekends.
