<u>The New Hampshire Municipal Energy</u> <u>Assistance Program</u>

Decision Grade Audit Report

New Castle Town Hall 49 Main Street New Castle, NH 03854

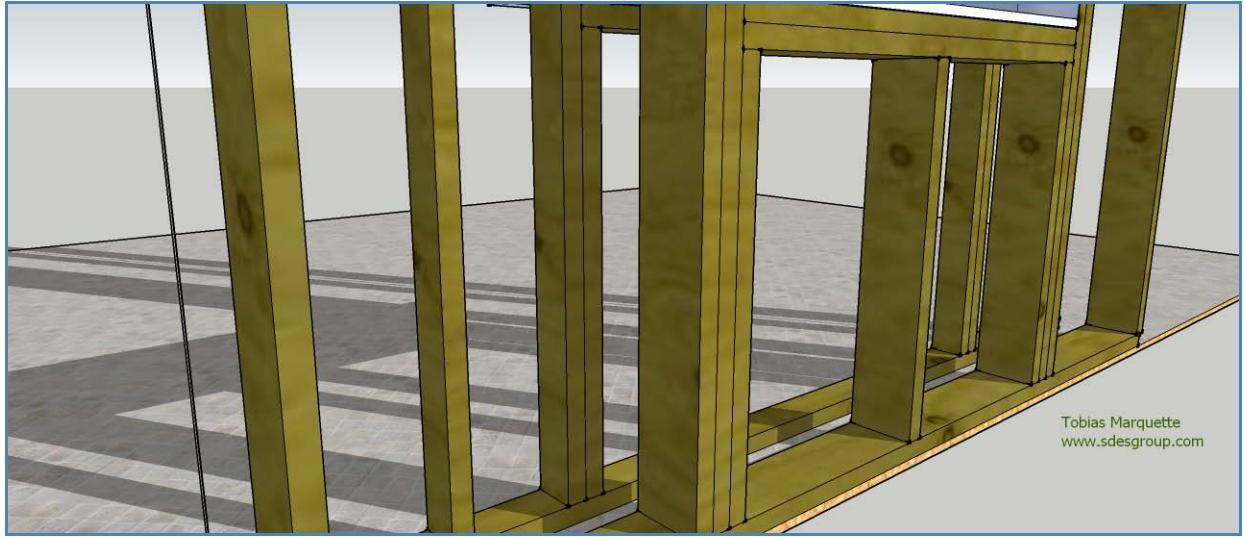
It could be possible to blow cellulose in the lower portion of this wall to deal with the weak spots; however, this may be more effort than it's worth. Our recommendation is to focus air-seal and insulation efforts on the ceiling and crawl space at this time. Figure 11 shows an example of a double stud wall. In this case, it would take a major renovation to accomplish this. It would require removing all of the exterior wall finish, building a second exterior wall against the first, then re-insulating the wall. It would also require moving electric boxes, radiators, and fabricating jamb extensions for the window trim. Because energy prices are still relatively low, this type of project would require consideration towards the long term use and environmental impacts of operating this building.

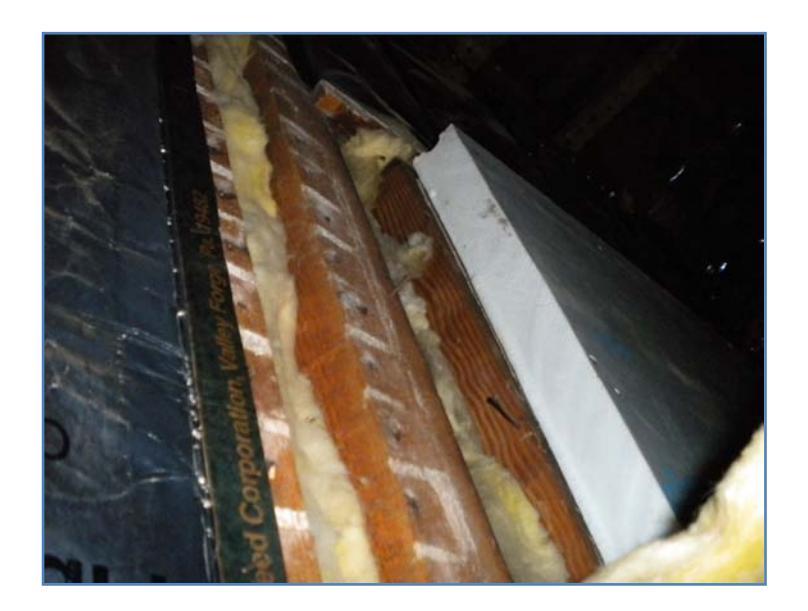
Figures 14, 15 and 16 display some of the ways in which heat moves through the second floor ceiling after it has made it past the first floor. About half of the second floor ceiling is insulated with 8 to 10 inches of vermiculite insulation which only has an R-value of about 2 per inch. This R-20 at best is only 1/3 of what is required by today's building codes. In order to improve this area of the ceiling, we would recommend having the vermiculite removed by a certified company, ceiling any penetrations to the space below, and re-insulating the ceiling with cellulose insulation.

Also visible in Figure 14 is a large amount of heat coming from the wall cavities of the partition wall. What is likely occurring here is the following:

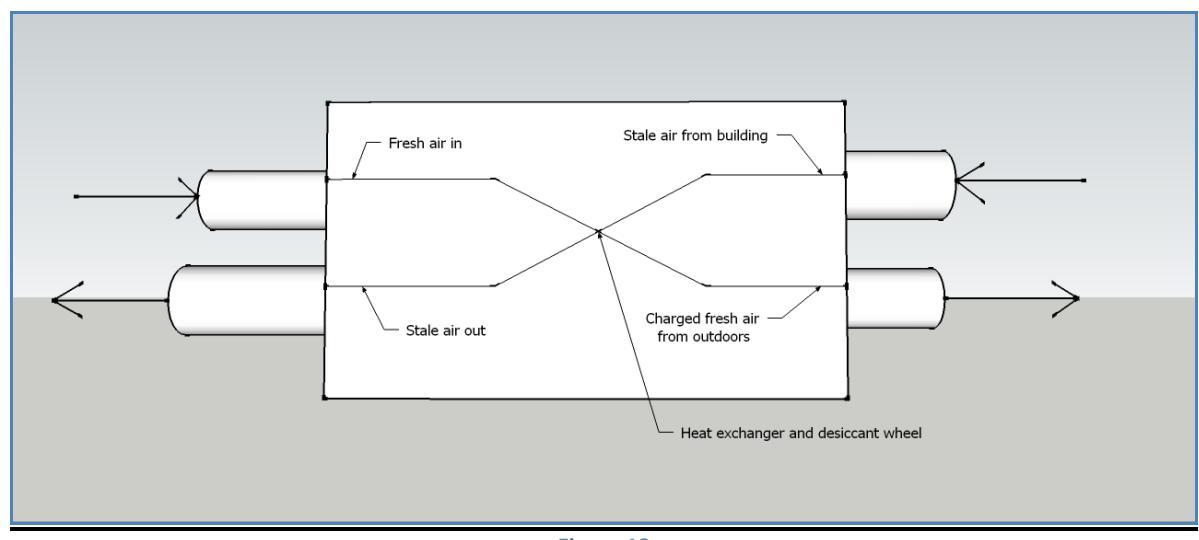
Figure 18

If the recommendations for air-sealing and insulating are carried out, it will likely then be necessary to install some sort of mechanical ventilation. The most efficient way to provide fresh air in this case would be with an energy recovery ventilator (ERV). An ERV functions by removing a percentage of the stale air from the return plenum, and then introducing charged, fresh air to the return plenum right before the air-handler. In the winter, warm/stale air being removed from the building will charge the incoming fresh air with a heat exchanger located inside the ERV. Conversely, in the summer months the exhausted cool/stale air from the interior will cool down the hot/humid air from the exterior before entering the air-handler. An ERV has a desiccant wheel as well. This allows for the transfer of moisture. In the winter months, moisture in the summer, dry/conditioned air from the interior will remove, at least a portion of, the moisture from the humid incoming air - see Figure 18. One of these units could be installed above the suspended ceiling of the first floor and would likely cost about \$2000.00.

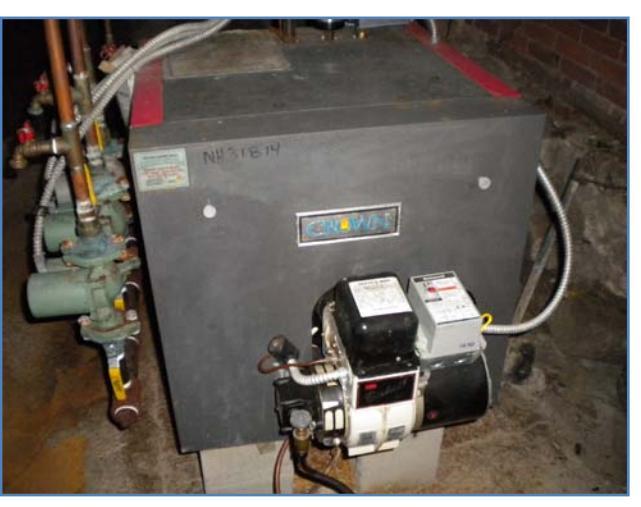
The building is heated with one oil fired boiler with a rated BTU input of 160,000 and a rated BTU output of 130,000. This boiler's combustion efficiency is about 82%. There are three zones tied to this system, each providing heat to three sections of the first floor. The distribution pipes are located in the crawl space, and none are insulated. There are three thermostats, one located in each zone. One of the thermostats is digital/ programmable and seems to be functioning properly. The other two do not appear to be functioning properly. They are misinterpreting the temperatures in the room,

and are unable to control the functions of the boiler. For example; the thermostat in the Selectmen meeting room may be set to 62°F. The temperature in the room is actually 72°F and the radiators are being supplied heat. Replacing these old thermostats should be the first step to determining appropriate functioning of the zone. If this is done and there still seems to be comfort issues and inefficient distribution of heat, a further examination into the piping schematics and pumps will be necessary. Though there are more efficient boilers available, we do not recommend replacing this unit at this time. The efficiency gain would not be substantial enough to produce a wise financial investment. When the boiler is in need of replacement, install the most efficient system available. Switching to a propane fired modulating/condensing boiler would certainly be the most efficient way to produce heat in this location, but may not be the least expensive at today's current prices for propane. The decision to do this now would have to be out of concern for reducing building operation emissions. Other generation alternatives should also be considered at that time.

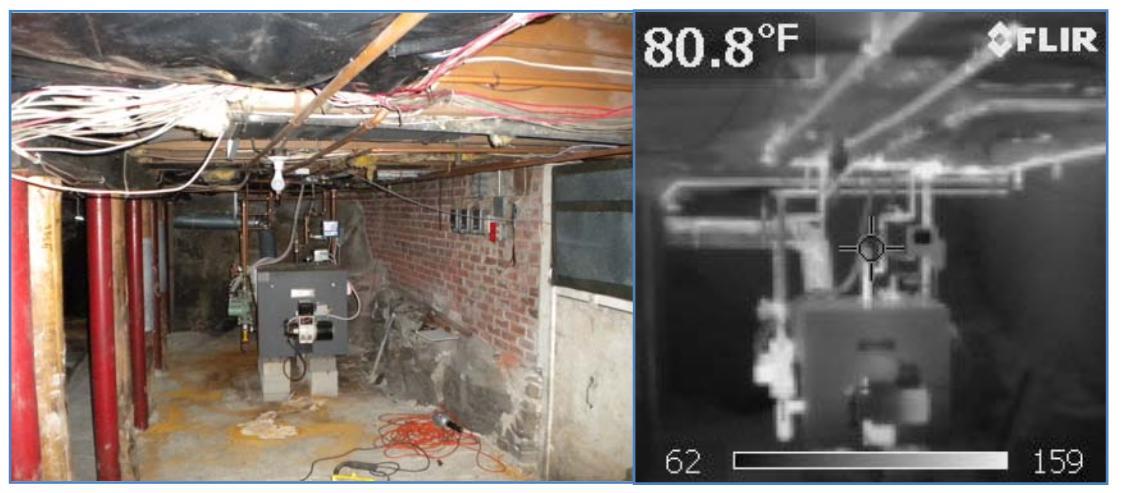
Figure 21

There is an electric hot water heater in the mechanical room. None of the pipes associated with this unit are insulated either.

- Arrange for an HVAC technician to come as soon as possible to affix the fallen pipes back into their original position.
- Insulate all of the copper piping in the crawl space and mechanical room, both for the heating system and the DHW system. Make sure this is done with special attention to detail, using a high R-value pipe insulation.
- Replace the two older thermostats with digital/programmable units. Determine a good schedule for temperature in the different zones and program set back temperatures appropriately. The schedule may vary between zones depending on the amounts of use.
- Install an outdoor reset to the boiler. These units are most effective when the boiler is connected to an indirect hot water heater, but even under the scenario, this unit should reduce consumption by about 5% to 7%.
