**New Castle Water Transmission Main Improvements
Progress Report - November 16, 2020**

PERMANENT REPAIR OF BRIDGE CROSSING COMPLETED

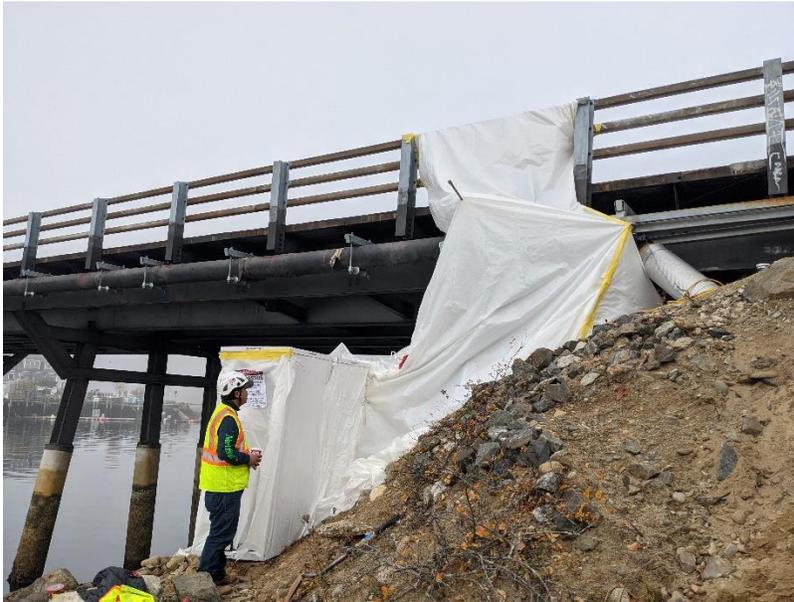
Erecting Temporary Containment Tent

The permanent repair required the removal of a small amount of the outer asbestos cement pipe. On Monday Nov 9th Granese, working through its asbestos abatement sub-contractor NorthStar removed about 12 inches of the outer pipe. This allowed the coupling to be centered on the joint. Thermal insulation was then applied.

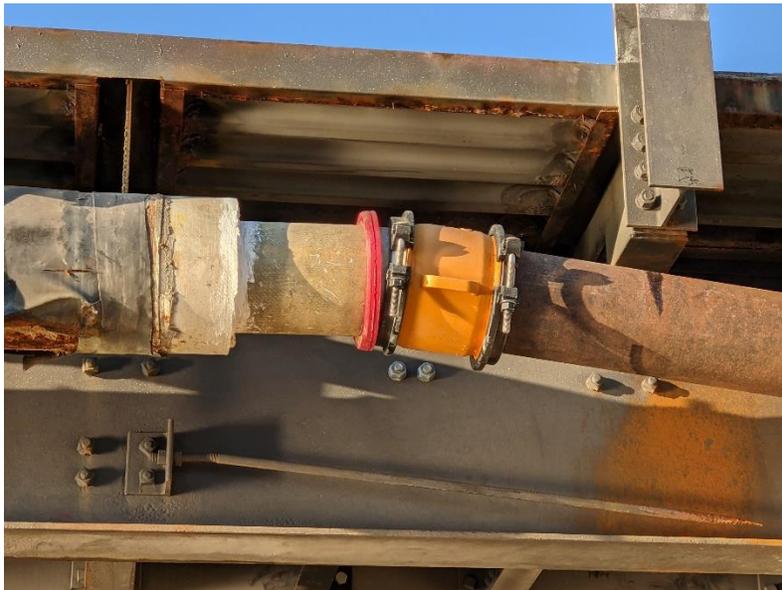
Outer asbestos cement pipe (on the left) Removed

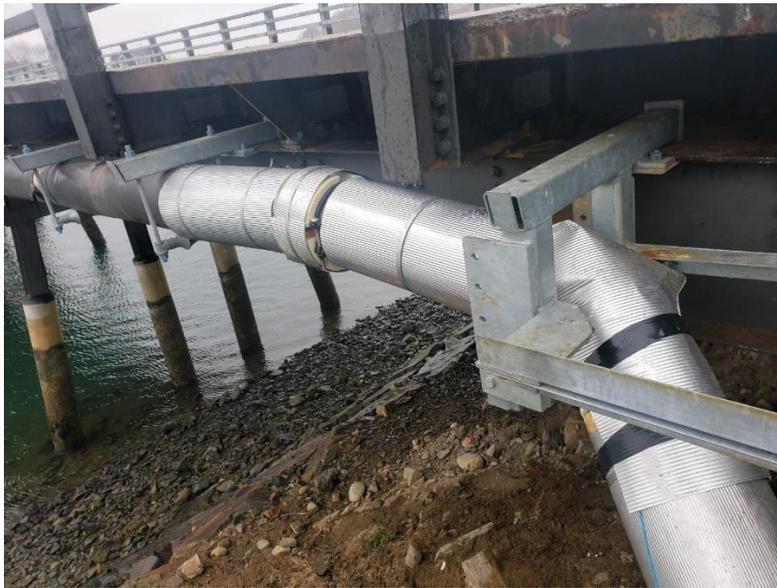
Completed Repair With Thermal Insulation

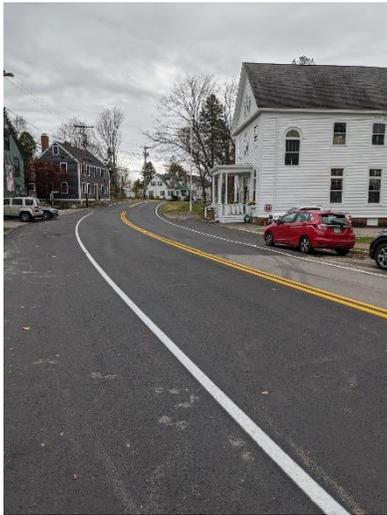
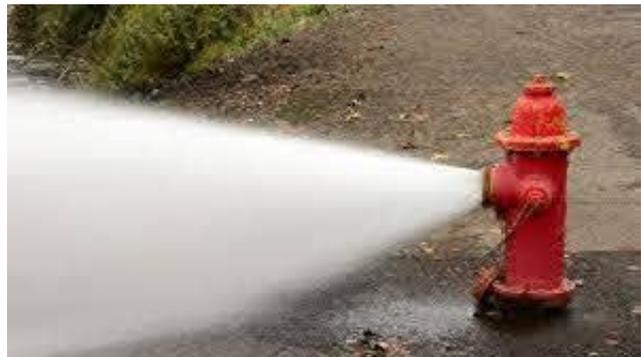
Granese and the Town also marked out the pavement for line stripping, stop bars, and crosswalks. Line stripping was performed during the early morning hours of Thursday November 12th. Hydrant flow testing began on Friday November 13th and will continue during the first part of this week.

During hydrant testing the fire hydrant is opened as wide as possible to allow as much water as possible to leave the distribution system. The amount of flow will be measured as well as the static and residual water pressures. This information will be compared with similar data obtained prior to the improvements. Water pressure will fluctuate during hydrant flow testing. There are over 30 hydrants that will be tested over a 3-day period so do not be surprised if you experience fluctuations in water pressure. The high flows may also stir up sediment that has accumulated on the inside of the water mains. This will result in colored water at the tap. If this happens let your water run until the discoloration disappears.
